⑥ National Dam Inspection Program. Big Piney Run Dam (Inventory Number NDS-MD-9), Ohio River Basin, Piney Creek, Garrett County, Maryland. Phase I Inspection Report.

BIG PNEY RUN DAM

## PHASE I INSPECTION REPORT

by  
BERGER ASSOCIATES, INC  
CONSULTING ENGINEERS  
HARRISBURG, PA.

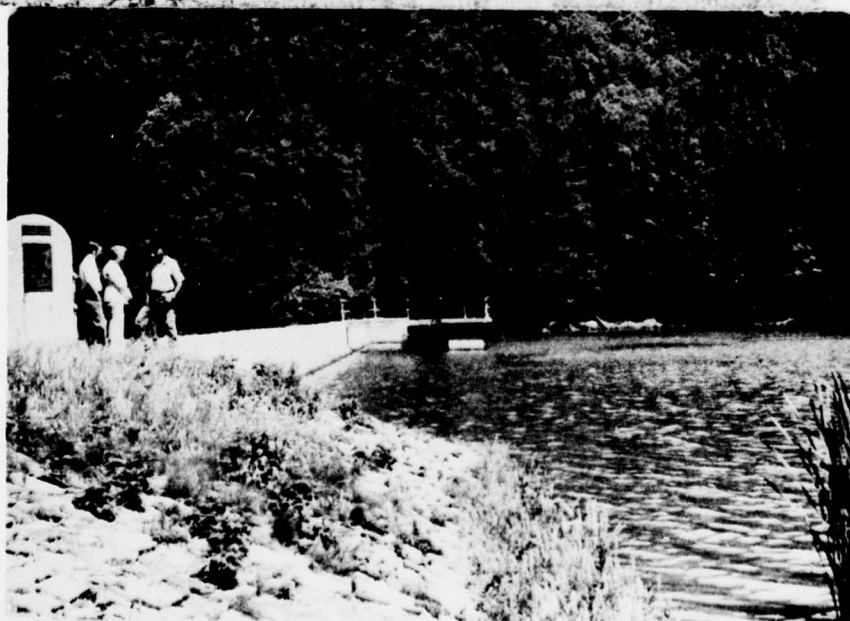
Embankment  
Left Abutment  
(South)

This low but relatively long earthfill abutment was in good condition. No signs of sloughing were detected and no seepage was noticed. Some trees were growing on the embankment, but the presence of a concrete core wall, the small height of the embankment and the relatively flat area downstream of this embankment makes these trees less objectionable. Adjacent to the first buttress wall the embankment crest has a depression for a length of 20 feet with a maximum depth of 15 inches.

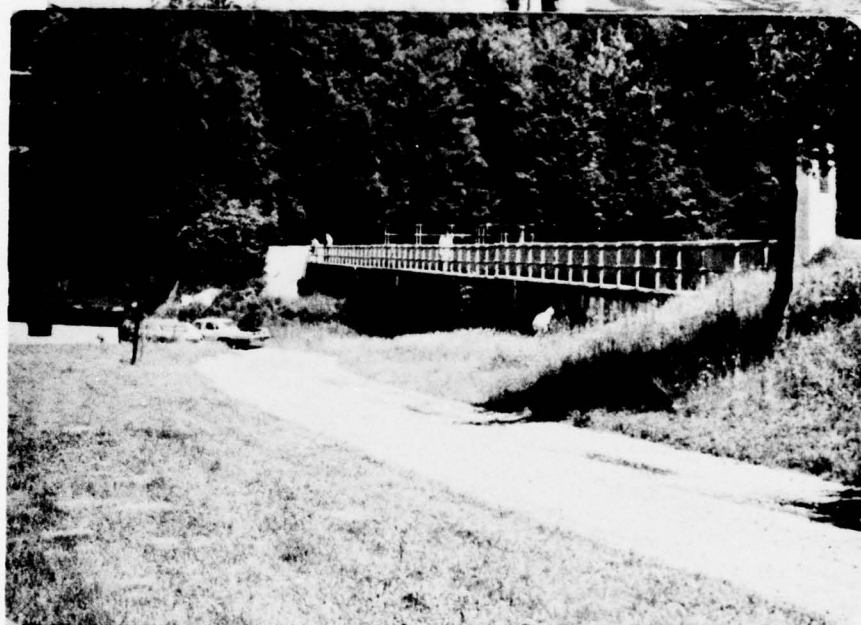
Top of Dam

Several light posts were installed on top of the parapet wall. The type of construction used for anchoring these light posts deteriorated the concrete and some deep gaps are in the parapet wall (Plate V, Appendix D). However the water coming through these gaps would not endanger the structure.
